Treated Wood in Aquatic Environments

A Specification and Environmental
Guide to Selecting, Installing and
Managing Wood Preservation Systems
in Aquatic and Wetland Environments

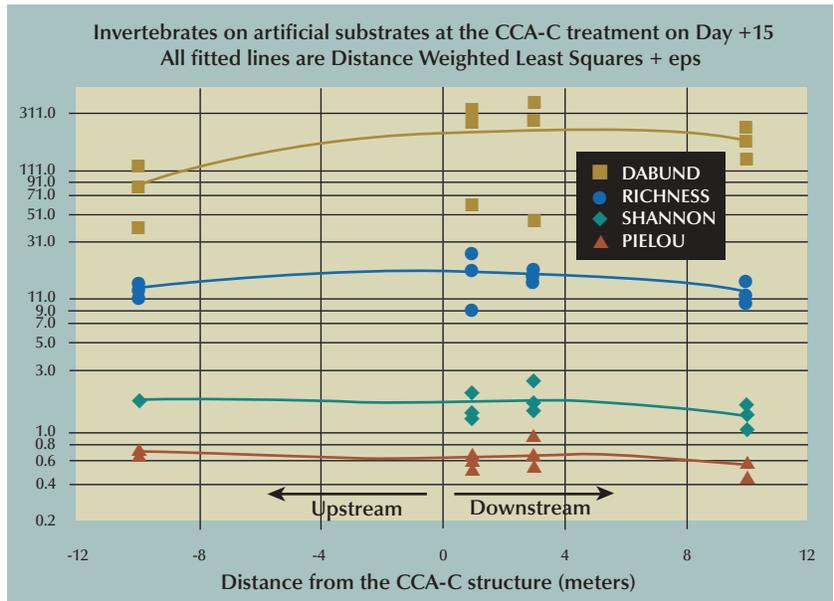
Figure 2 describes the response of invertebrates most exposed to the peak concentrations of dissolved copper observed two weeks after construction of the CCA-C viewing platform. Copper declined dramatically in all subsequent samples confirming that this first two-week period represented the worst case for this part of the insect community.

As many or more invertebrates were collected from the artificial substrates located immediately next to the treated wood (0 to 4 meters distance on chart) as were observed at the upstream control (-10 meters distance on chart). All of these indices (which measure the numbers and kinds of invertebrates and how well integrated they are in the community) showed no significant changes caused by the structure.

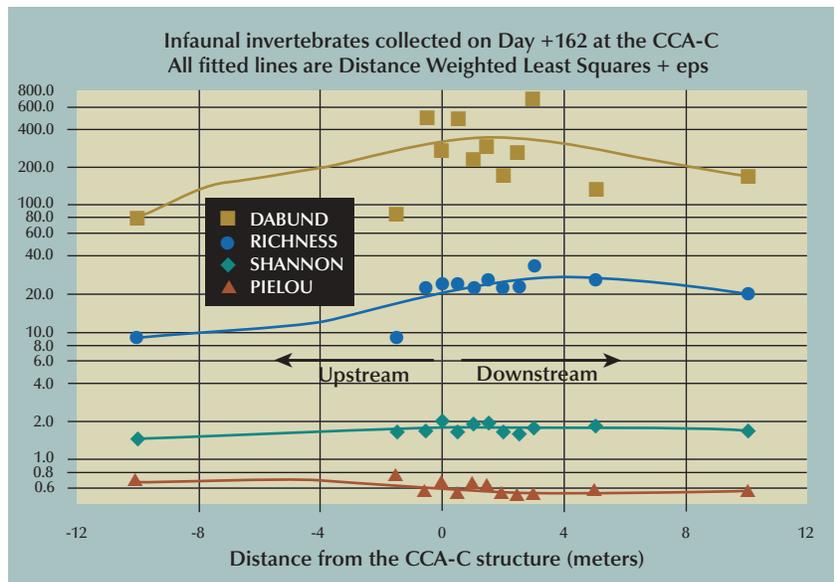
Figure 3 above describes the community of animals that live in the sediments (infauna) at the end of the study when sediment concentrations of all metals had reached their peak. Again, there is no indication that the CCA-C structure resulted in a compromise of these infauna, which are sessile (stationary) and had been exposed to the pressure treated wood structure for a year. The same results were obtained for the other two preservatives. It is impossible to prove a negative and therefore we cannot state that there could never be an adverse effect associated with these structures. *What we can say is that this worst case study did not reveal any adverse environmental effects and these results indicated that these preservatives can safely be used in sensitive wetland areas.*

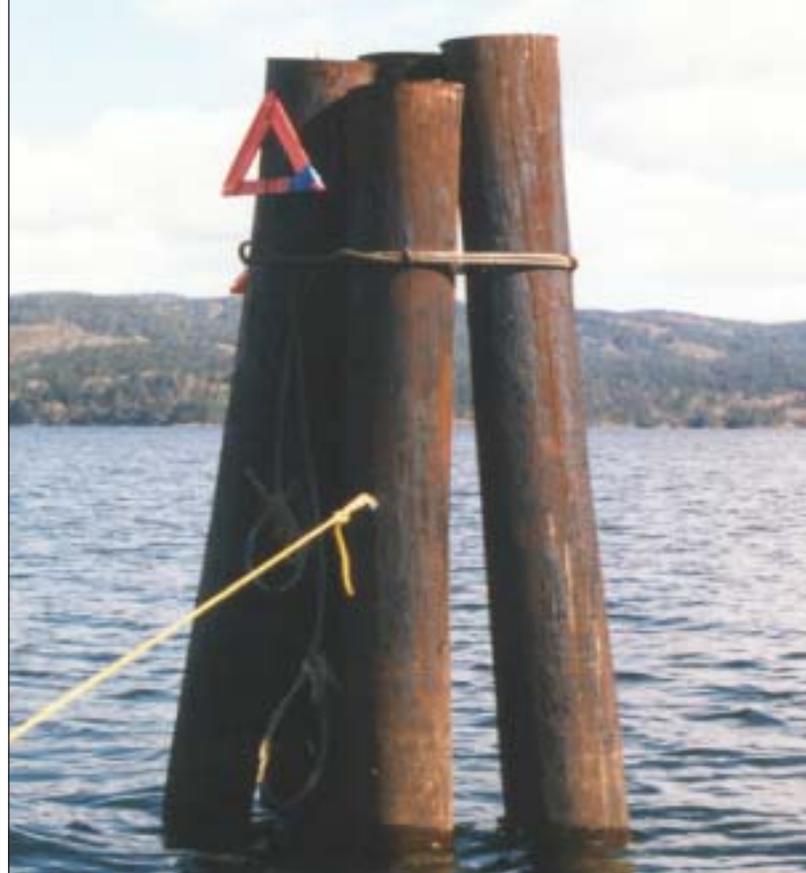
New creosote-treated dolphin used to evaluate creosote in Sooke.

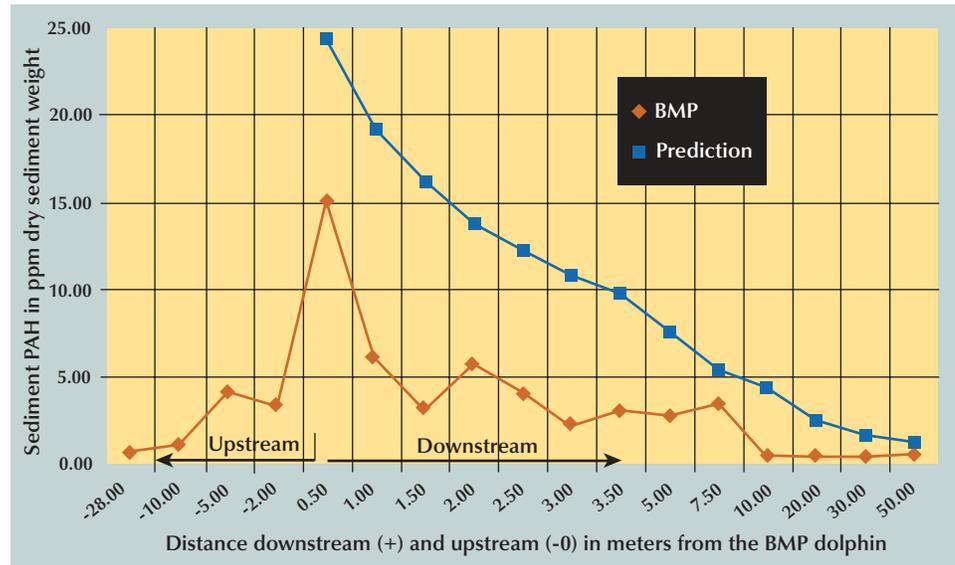
- Creosote did migrate from the piling and accumulate in sediments downcurrent from the piling. As shown in Figure 4 below, the actual accumulation of PAH in sediments (red line) was less than that predicted in the model (blue line). These sediment concentrations also peaked earlier and declined faster than predicted. These models have been field-verified repeatedly over the last six years. In every case, they have proven conservative from the environment's point of view – that is, predictions of PAH accumulation were higher than what was actually observed.

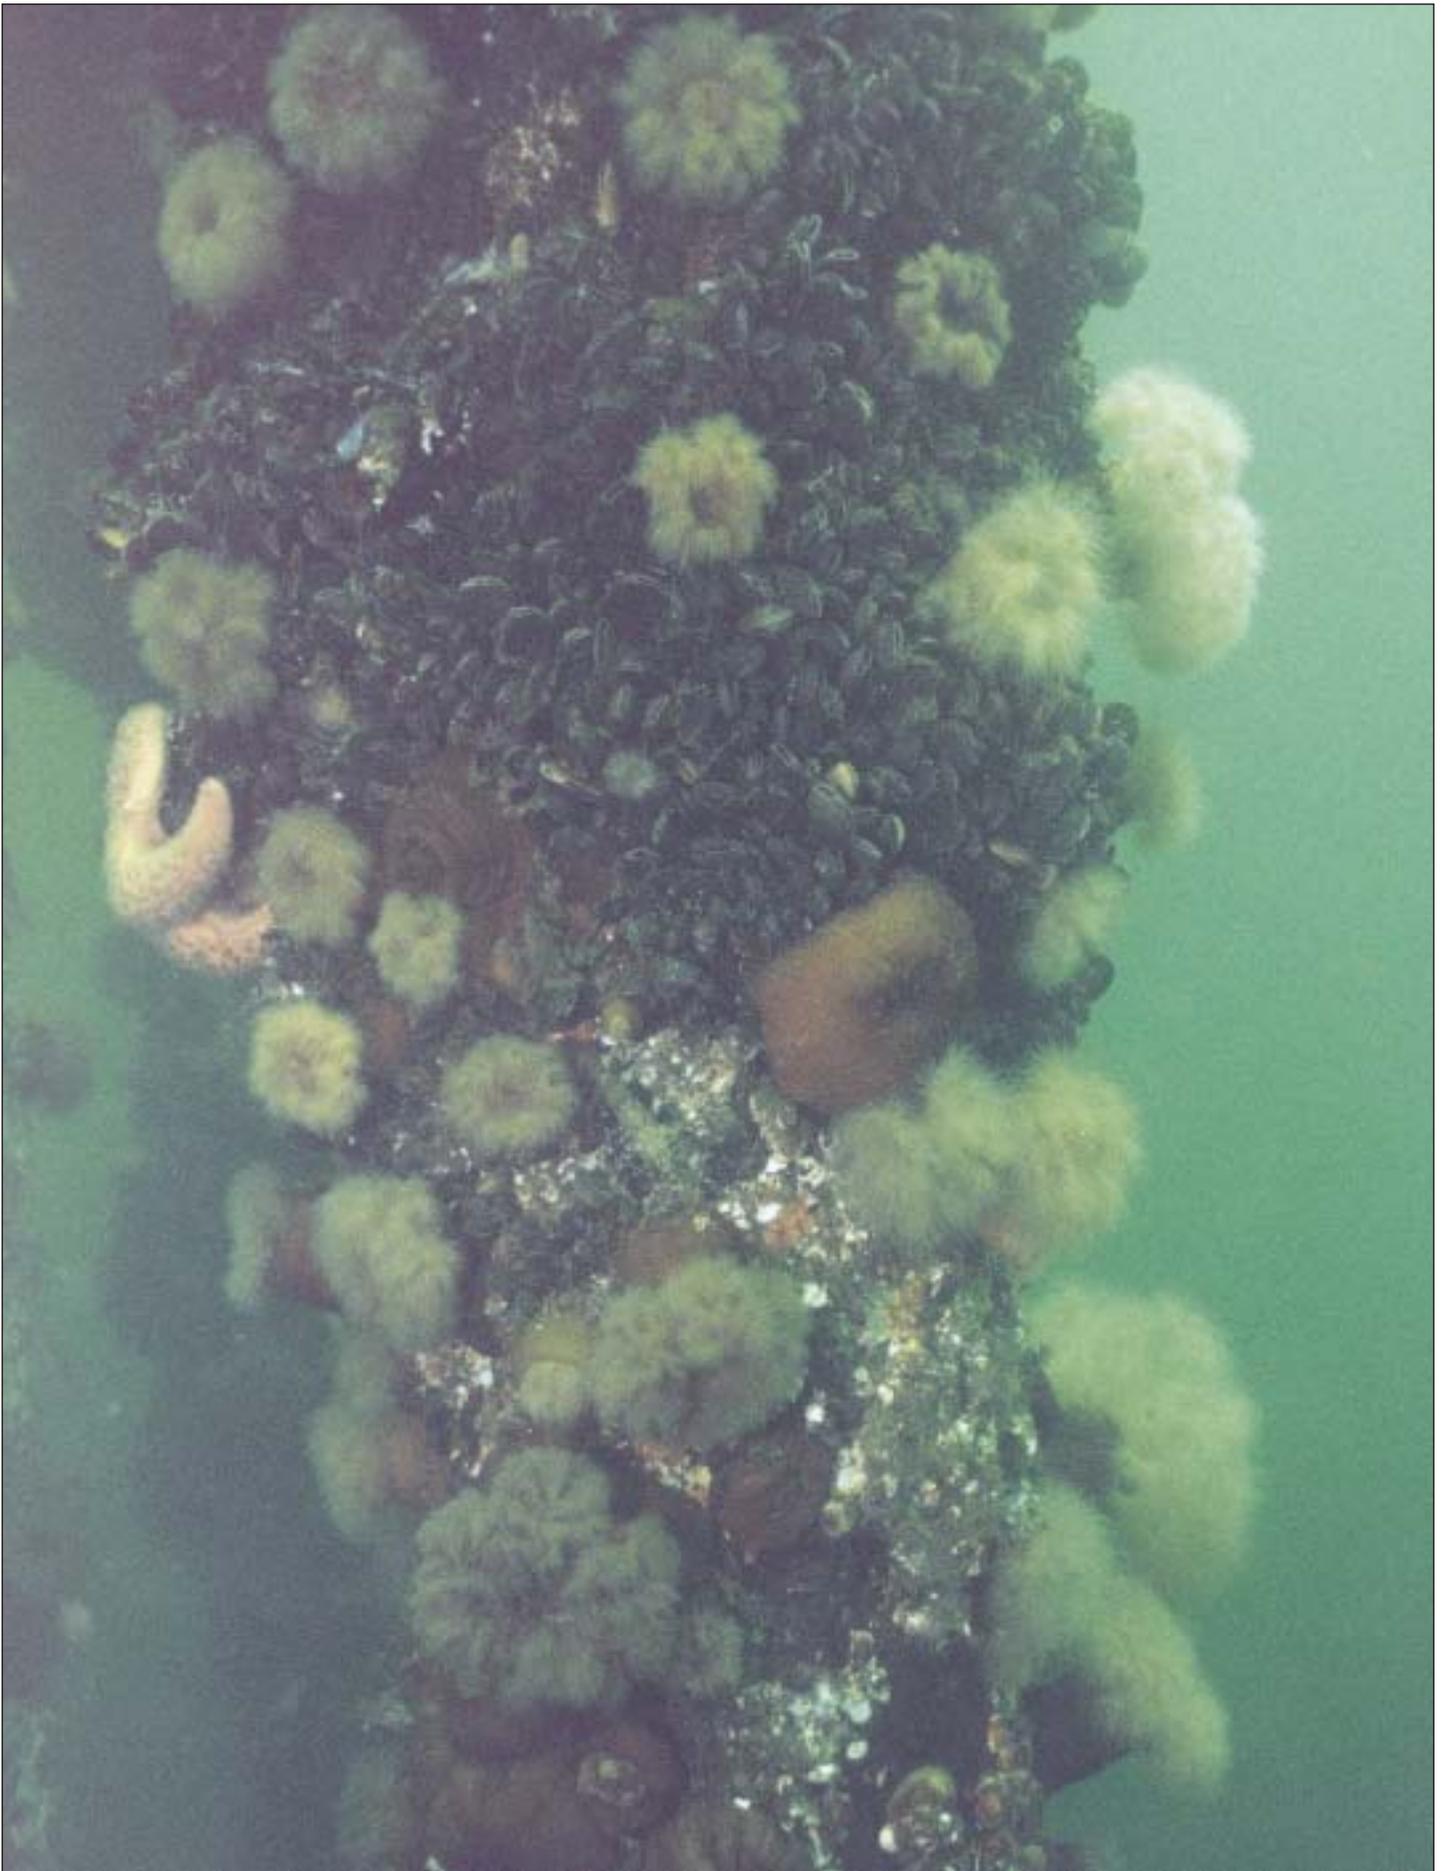
Invertebrate community growing on a new creosote-treated marine piling in Sooke Basin

- The continually immersed portions of the creosote-treated piling were quickly overgrown with a rich and abundant community of fouling organisms. The full-page photograph on the next page shows one of the newly treated creosote piling at the end of the study. Dozens of species were identified including fish, shrimp, nudibranchs and tunicates such as *Cnemidocarpa finmarkiensis* shown at left. From an intuitive point of view, this luxuriant fouling community does not suggest that these piling were creating a toxic environment.

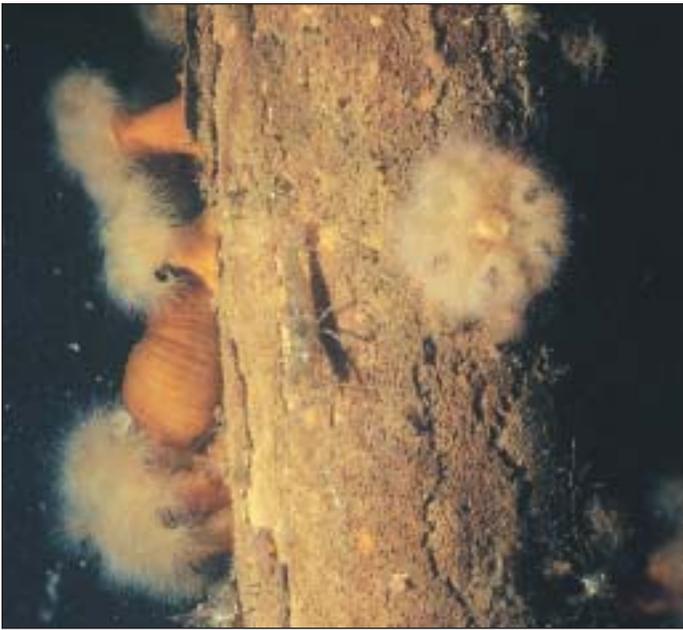
The untreated piling were deteriorating and did not support a vibrant fouling community

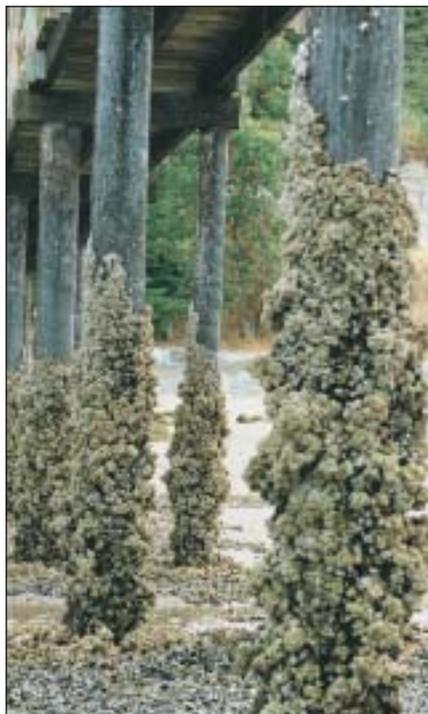
The personal use pier shown here is constructed of creosote-treated piling with ACZA-treated walkways

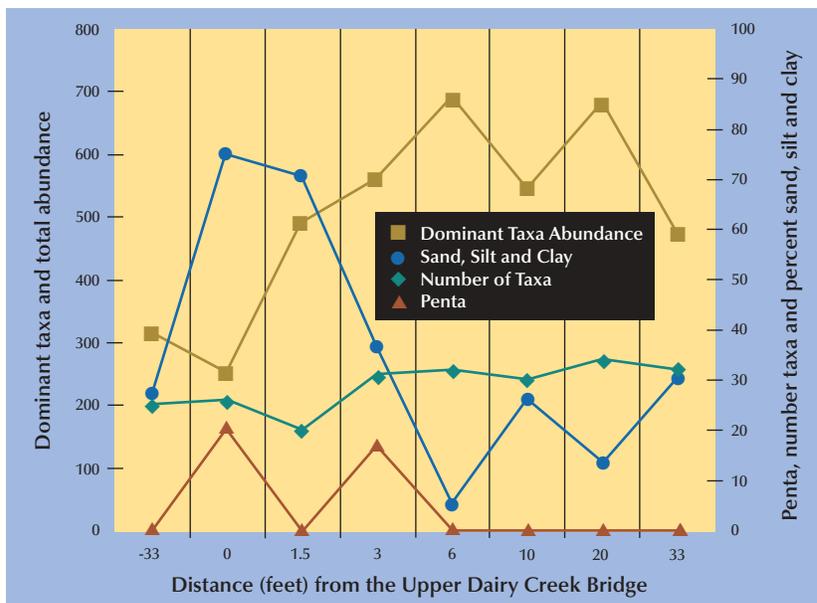
Figure 5

These two bridges were located over salmon-spawning rivers with sand-gravel and cobble substrates supporting a vibrant community of pollution-intolerant aquatic insects in the Orders Ephemeroptera (mayflies) and Trichoptera (caddis flies). The larvae of these Orders are generally associated with fast-moving oligotrophic streams and rivers. The biological response of this sensitive community is illustrated in the figure below. It describes sediment pentachlorophenol concentrations ($\mu\text{g}/\text{kg}$) in red; the proportion fine-grained sediments (sand, silt and clay) in blue; biological response described by the number of species (green); and the abundance of invertebrates (brown).

Note that the number of species and the total abundance of invertebrates were much higher three feet downstream from the bridge's drip line where the proportion of fine sediments dropped from 70 to 80 percent to about 40 percent. Also note that invertebrate abundance peaked where the proportion of fines decreased to between five and 12 percent. There were as many species and as many animals downstream from the bridge as there were at the upstream control. And there was essentially no correspondence between invertebrate community and the small amount of pentachlorophenol observed under the bridge and at the station located three feet downstream. Amphipod (*Hyaella azteca*) bioassays also found no evidence of toxicity in sediments from either of these pentachlorophenol-treated bridges. The invertebrate community was far more influenced by the substrate type than by the bridge.

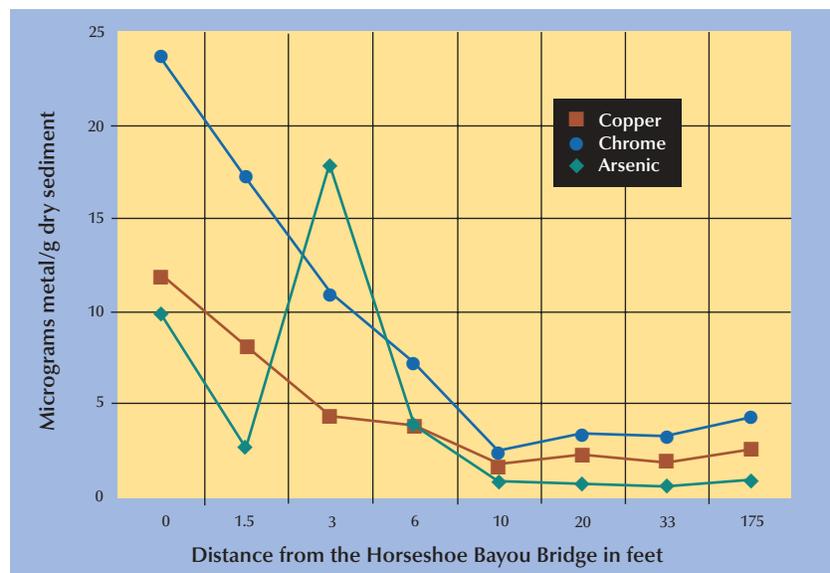
Figure 7

It should be noted that all metals were below their respective water quality criteria of 3.1 μg copper/L, 36 μg arsenic/L and 50 μg chromium (VI)/L. As shown in Figure 7, increased sediment concentrations of all three metals were observed within 10 feet of the bridge.

The reason for the increase illustrates an important point in the construction of treated-wood structures. As previously noted, this is a truly massive bridge. One thousand four hundred fifty-eight holes were drilled in the bridge to bolt together the heavy-duty treated-wood railing. Each hole was 3/4" in diameter and approximately 14" long. The drill shavings were not contained and they blew into the estuary where they could be seen on the bottom all around the bridge.

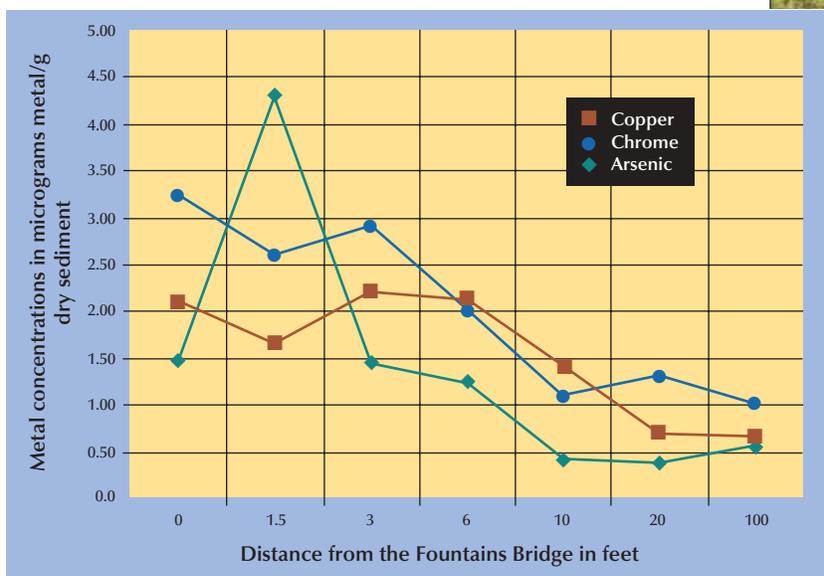
Figure 8

The second bridge examined in San Destin was the 8-year-old Fountain Bridge, which crossed a freshwater marsh. This older bridge was examined to evaluate the accumulation of metals in sediments around the bridge and their effect on infauna. Increases in dissolved metals were not observed in the vicinity of the bridge in this essentially stagnant body of water.

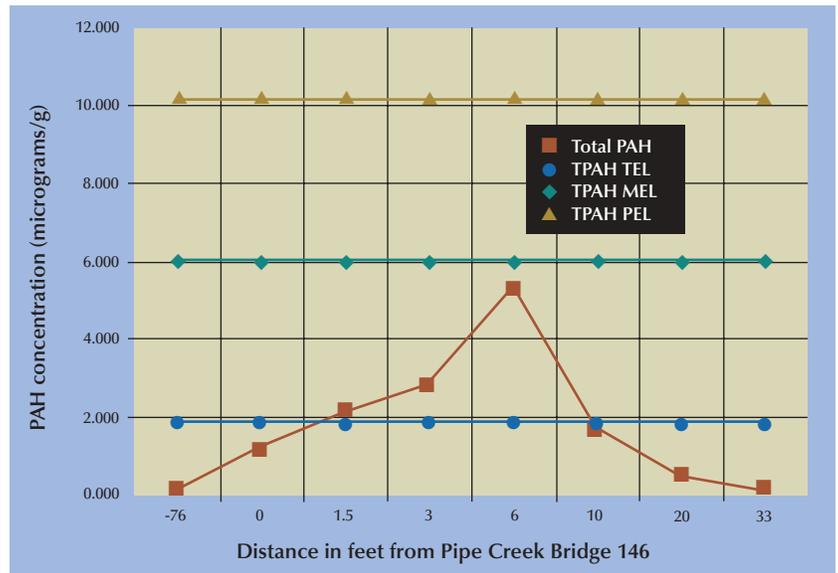
Figure 10

Sediment concentrations of polycyclic aromatic hydrocarbons (PAH) are described in Figure 10. This graph also includes sediment quality benchmarks described as the Threshold Effects Level (TEL), a value below which adverse biological effects are not generally observed under any condition, and the Probable Effects Level (PEL), a value above which increasingly severe biological effects should be anticipated in most environments. The mean of these values or MEL is also displayed. This mean is increasingly used as a reasonably protective benchmark for assessing environmental risk. Maximum sediment PAH concentrations between 1.5' and 6.0' downstream from the bridge exceeded the Threshold Effects Level for TPAH but not the Mean Effects Level. This suggests that adverse effects could be anticipated in a community of the most sensitive organisms.

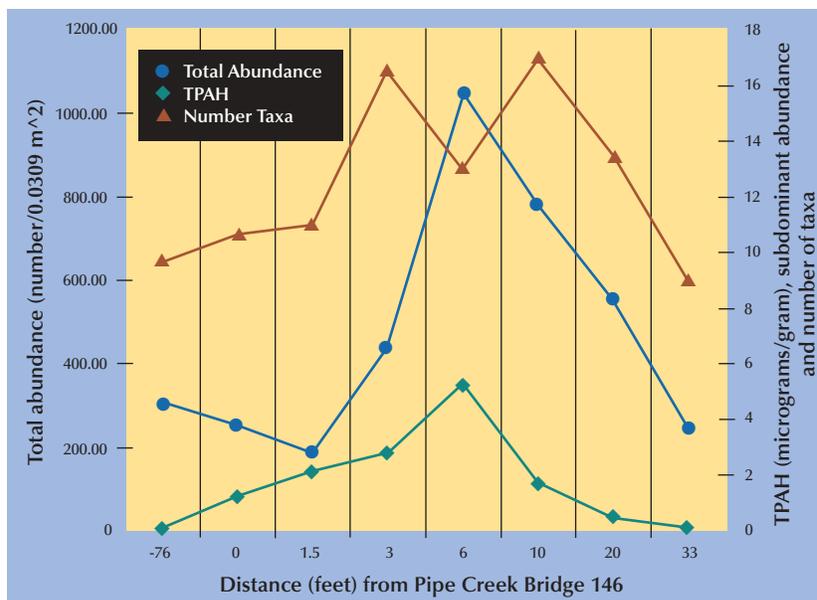
Figure 11

The point that should be made is that neither of these bridges lost enough PAH to affect the creek's invertebrate community. The results of this study were also consistent with those obtained in Sooke Basin. Lower sediment TPAH concentrations were observed at the older bridge and higher concentrations at the new bridge. Experience has shown that creosote- and pentachlorophenol-treated bridges are most likely to lose preservative during the first year following construction – particularly during extended periods of high ambient temperatures. Oil-type preservative losses decline significantly with time.
